Magellan/Galileo Solder Joint Failure Analysis and Recommendations

Ronald G. Ross, Jr.

September 15, 1989

Jet Propulsion Laboratory
California Institute of Technology
Pasadena, California

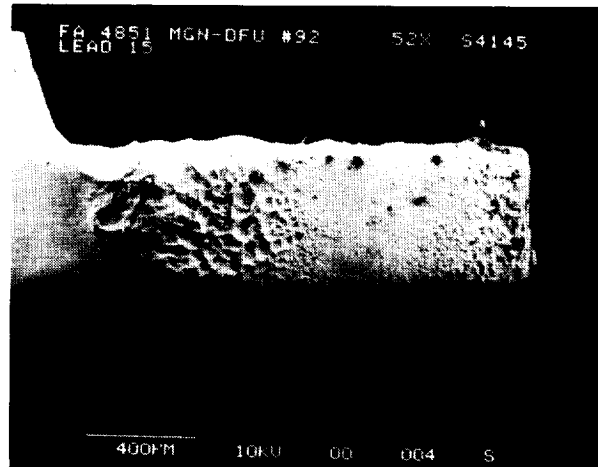
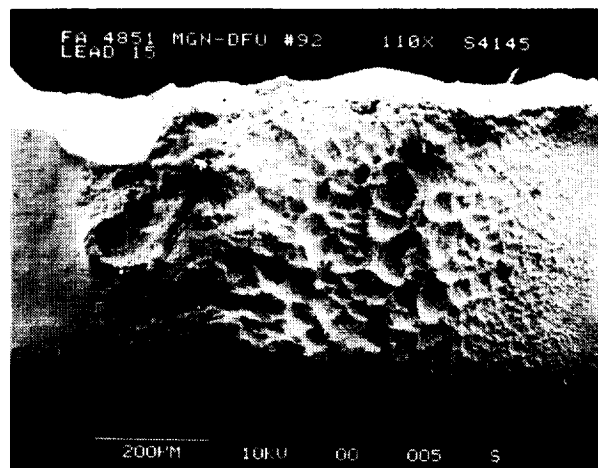
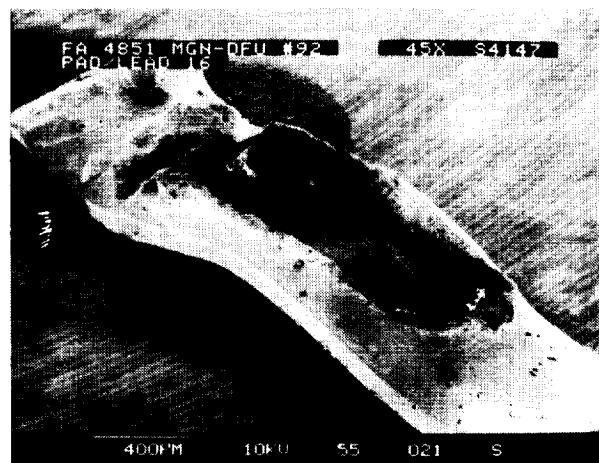
In the subsequent scanning electron microscope (SEM) analyses of the failed leads, the solder fracture surfaces displayed good lead wetting and good elongation at break (Fig. 5). This indicates that the solder joints themselves were not at fault, but that excessive forces are the most likely cause of failure. Another interesting finding was that all of the leads on the opposite side (pins 1 to 8) of the failed DIP were in excellent condition as shown in Fig. 6.

Fig. 5. SEM photographs showing good solder fracture properties of foot and pad from failed (pin 15 and 16) solder joints

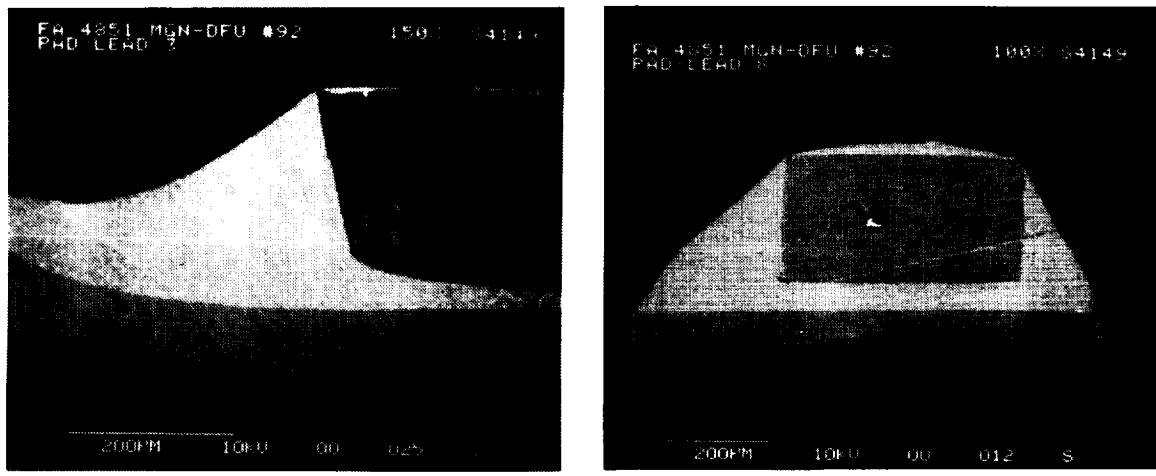
Fig. 6. SEM cross-sections showing excellent solder joints on opposite side (pins 3 and 8) of DFU part that failed open-circuit

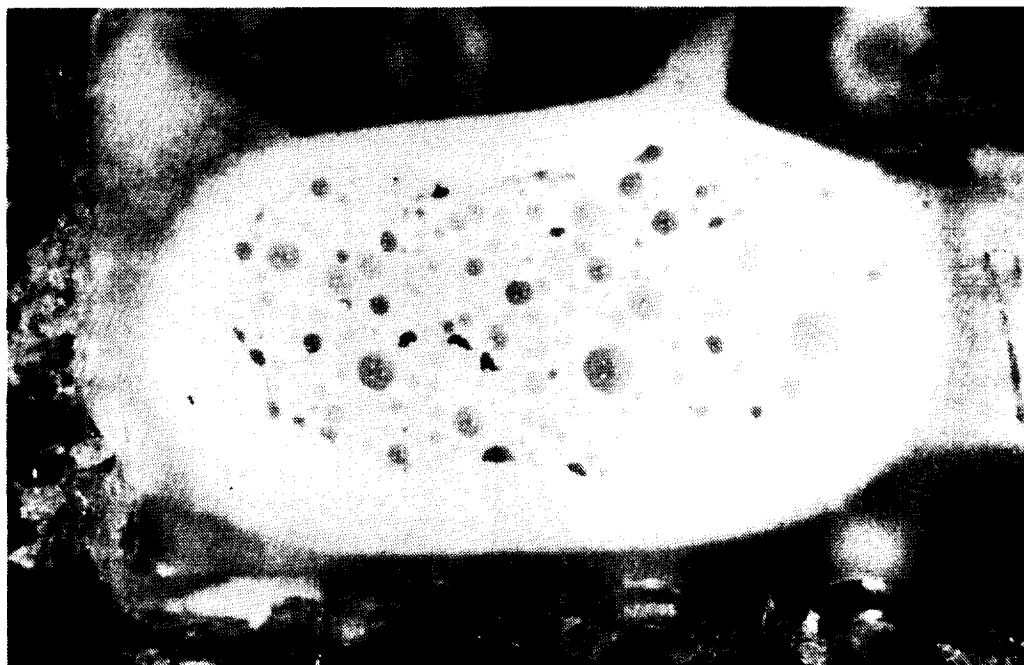
Pre-applied Alumina-Filled Solithane - Very severe stressing occurs when a bead of alumina-filled Solithane is applied beneath the part prior to part placement and soldering--even with no clear-Solithane over-coat. This mounting configuration, shown in Fig. 10(a), is the one that was used with the part that failed at KSC. A particularly stressful aspect of this mounting approach is the fact that the pre-application of the Solithane, prior to soldering, requires that the Solithane be exposed to the high part temperatures that can occur during soldering, and be exposed to multiple applications of solder-flux cleaning solvents. There is also evidence that this filled Solithane expands slightly when cured, perhaps due to the presence of, or generation of entrapped gas in the Solithane [4]. Fig. 11 shows the foamy nature of this material as it was found under the failed

Fig. 11. Foamy nature of alumina-filled Solithane under flight DIP

flight part. Although it was determined that most of the observed foaming is due to air entrapped during mixing, entrained moisture (either adsorbed from the air during mixing, or desorbed from the alumina filler powder) can cause a chemical reaction with the Solithane that produces CO₂ gas evolution similar to that in a rising cake [4]. Although this application technique leaves the solder joints easily inspectable, which was the reason behind its original choice, **the high level of stressing associated with this process as it is presently implemented makes it unsuitable for further use.**

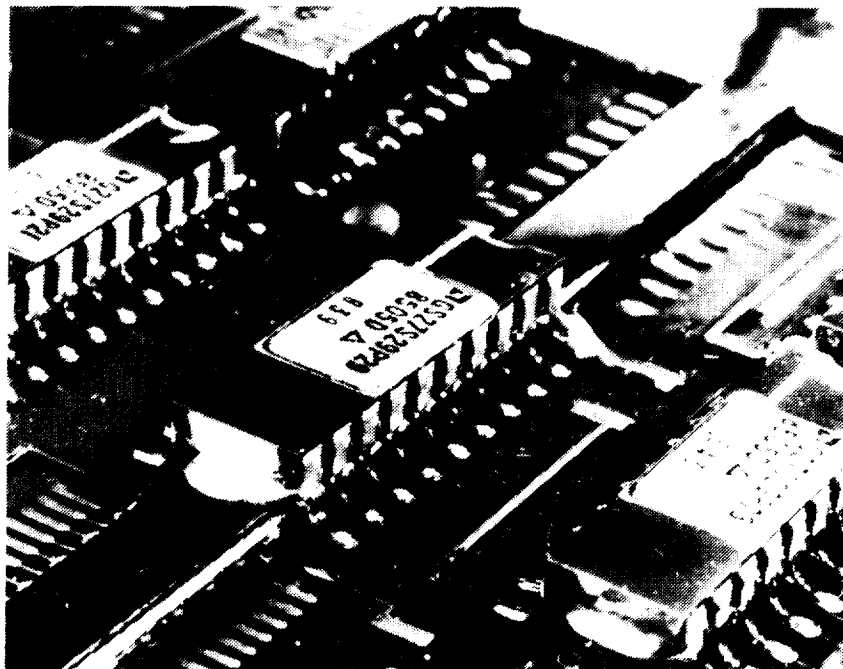
Copper Heat Sinks beneath DIPs - This construction, shown in Fig. 13, behaved almost identically to the alumina spacers--modest stressing with the stress propagating along the foot, but generally stopping short of the toe region. **Like the alumina spacers, this construction technique is considered marginal, but acceptable for flight environments with minimal thermal cycling. Research should be carried out to further reduce the modest levels of observed stressing with this construction.**

Fig. 13. DIPs mounted over 0.060" copper heat sinks

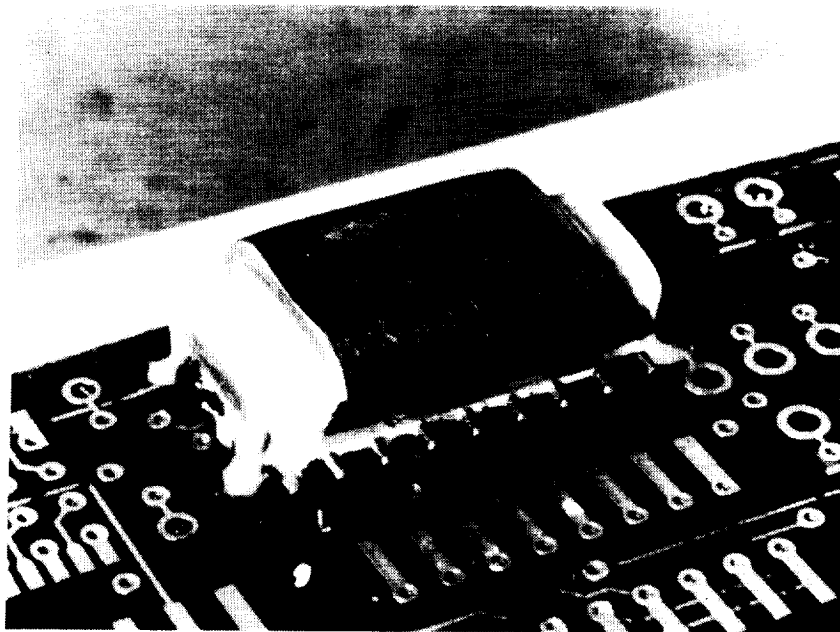
Radiation Shields - This construction, shown in Fig. 14, exhibited no significant solder-joint stressing, i.e. it was similar to the post applied alumina-filled Solithane. Inspection of the solder-joint heels was obscured by alumina-filled Solithane that extrudes from beneath the package.

Fig. 14. DIP mounted with Tantalum radiation shield

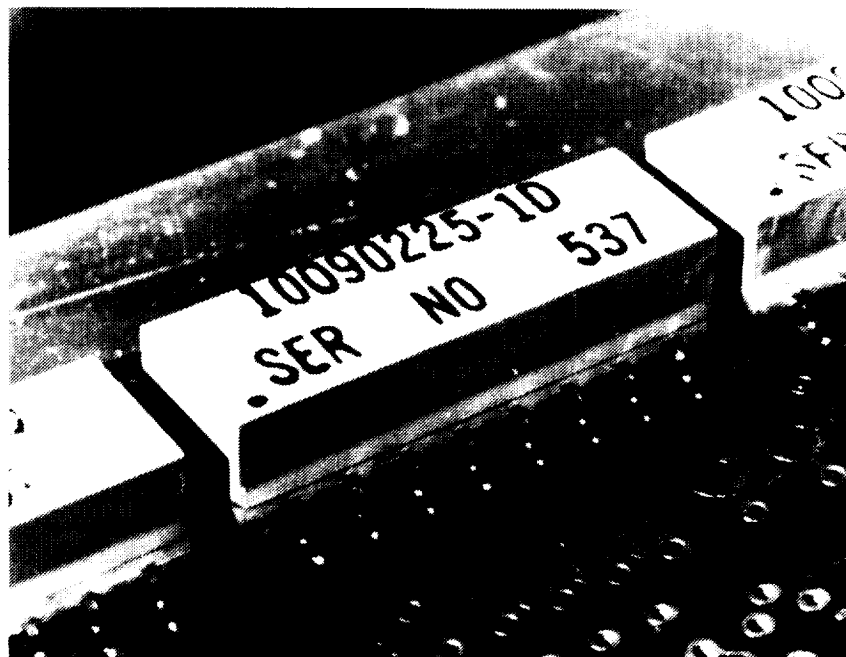
Interface Transformers - Interface transformers, shown in Fig. 15, are packaged in a special 16-pin DIP with a different high-compliance lead bend as compared to conventional IC DIPs. As a result, the package sits much closer to the board (only 0.020" to 0.030" gap) and can accommodate some vertical (normal to the board) motion. Although heavy stressing of end leads (typically pins 1, 8, 9 or 16) was sometimes observed, the problem could not be reproduced in testing. Most flight interface transformers were found to be free of stressing. It is suspected that the random cracking of end leads with this construction may be caused by the manner in which the leads were held during soldering; it is well known that if leads are held down (elastically deformed) during soldering, they are likely to subsequently crack due to creep-rupturing of the solder under the applied spring load as the leads attempt to return to their unstressed position. This type of failure is generally of a random nature (individual isolated leads), and the crack generally initiates at the toe and progresses toward the heel.

Fig. 15. JPL DIP interface transformer package

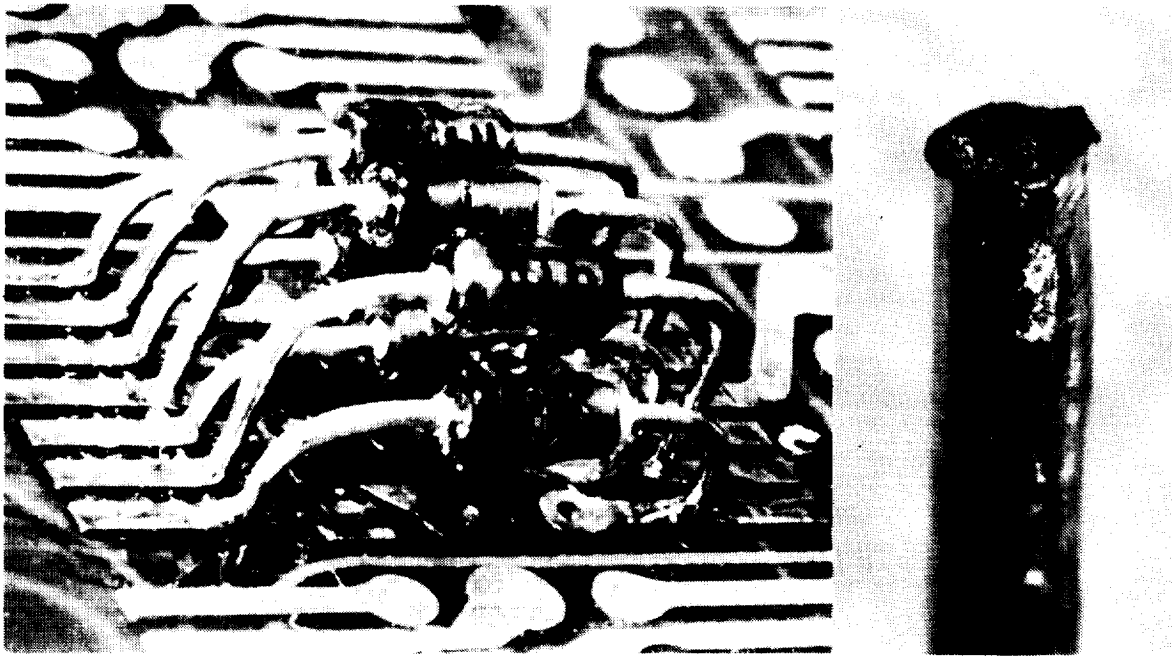
Fig. 27. Stub-mounted diodes used as substitute for unavailable diode flat-pack, and example of failed lead with no solder fillet

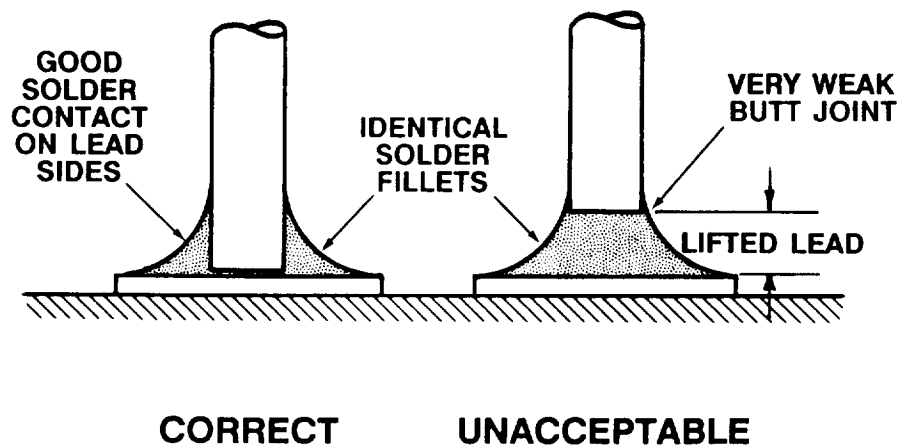
Fig. 28. Problem of poor inspectability of solder fillet on stub-mounted lead
